Castle Cement Limited

Carbon Capture and Storage Project – Padeswood, North Wales

Volume 4, Draft Technical Appendix 8.1

Archaeological Desk-Based Assessment

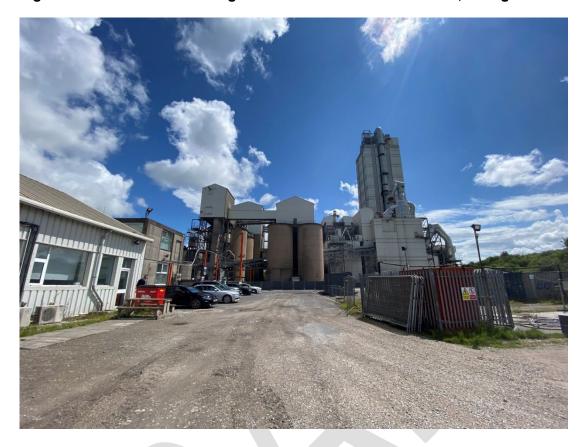
Figure 19 Area of hardstanding within the extant cement works, facing east

- 5.4.3 Within the extant cement works large areas of the ground were covered by hardstanding. In these areas it was not possible to ascertain either the absence or presence of any below ground archaeological remains (Figure 18, Figure 19, Figure 20, Figure 21 and Figure 22). Where there were areas of grass or earth visible no above ground indicators of possible below ground archaeological remains were noted (Figure 23, Figure 24, Figure 25 and Figure 26).

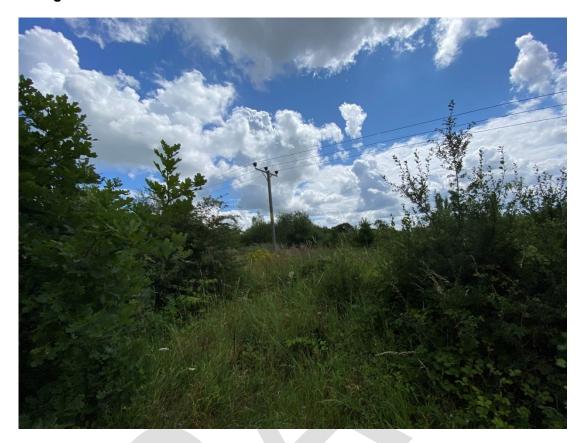
Figure 28 Visible remains of a crooked football pitch (401374) were not visible, facing north east

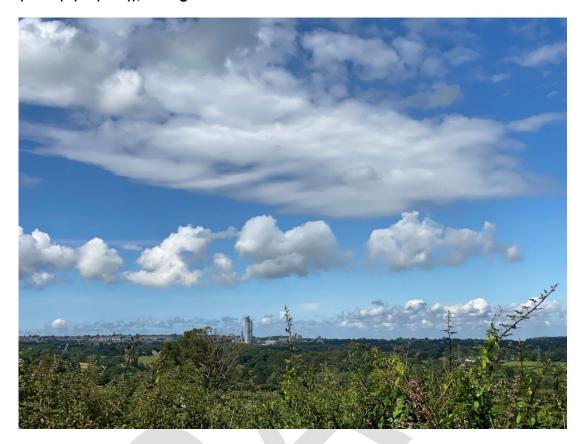
Figure 43 View towards Wat's Dyke (FL089) from Penyfforddd Station, facing north west

5.4.13 Wat's Dyke (FL089 adjacent to the Site's southern boundary, FL088 150m north east of the Site's south west corner, and FL090 700m south east of the Site's south east corner) was difficult to gain access to view directly. The areas appear to be well screened from the Site by vegetation for all three sections of the monument (**Figure 43**).
